Rolvenden gets stuck in!

An update on the overhaul of Terrier 2678.

Over the past few weeks the pace of work on Terrier 'Knowle' has picked up at Rolvenden. This update pulls together information and photographs from David Brenchley, Dan Dickson, Jamie Clapp and others.

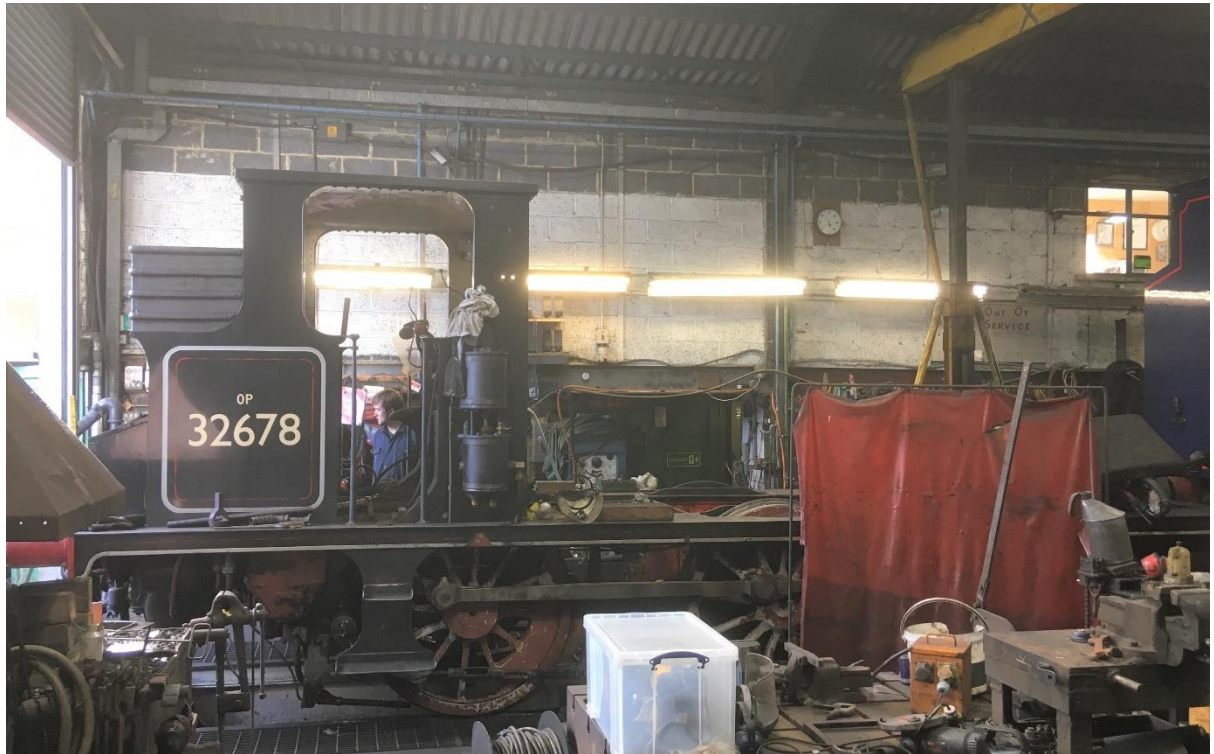
The Frames have been pressure washed to remove old loose paint and rusted areas are being needle gunned to prepare for painting. A number of other jobs have been tackled including new bolts to secure a loose left-hand eccentric sheave.

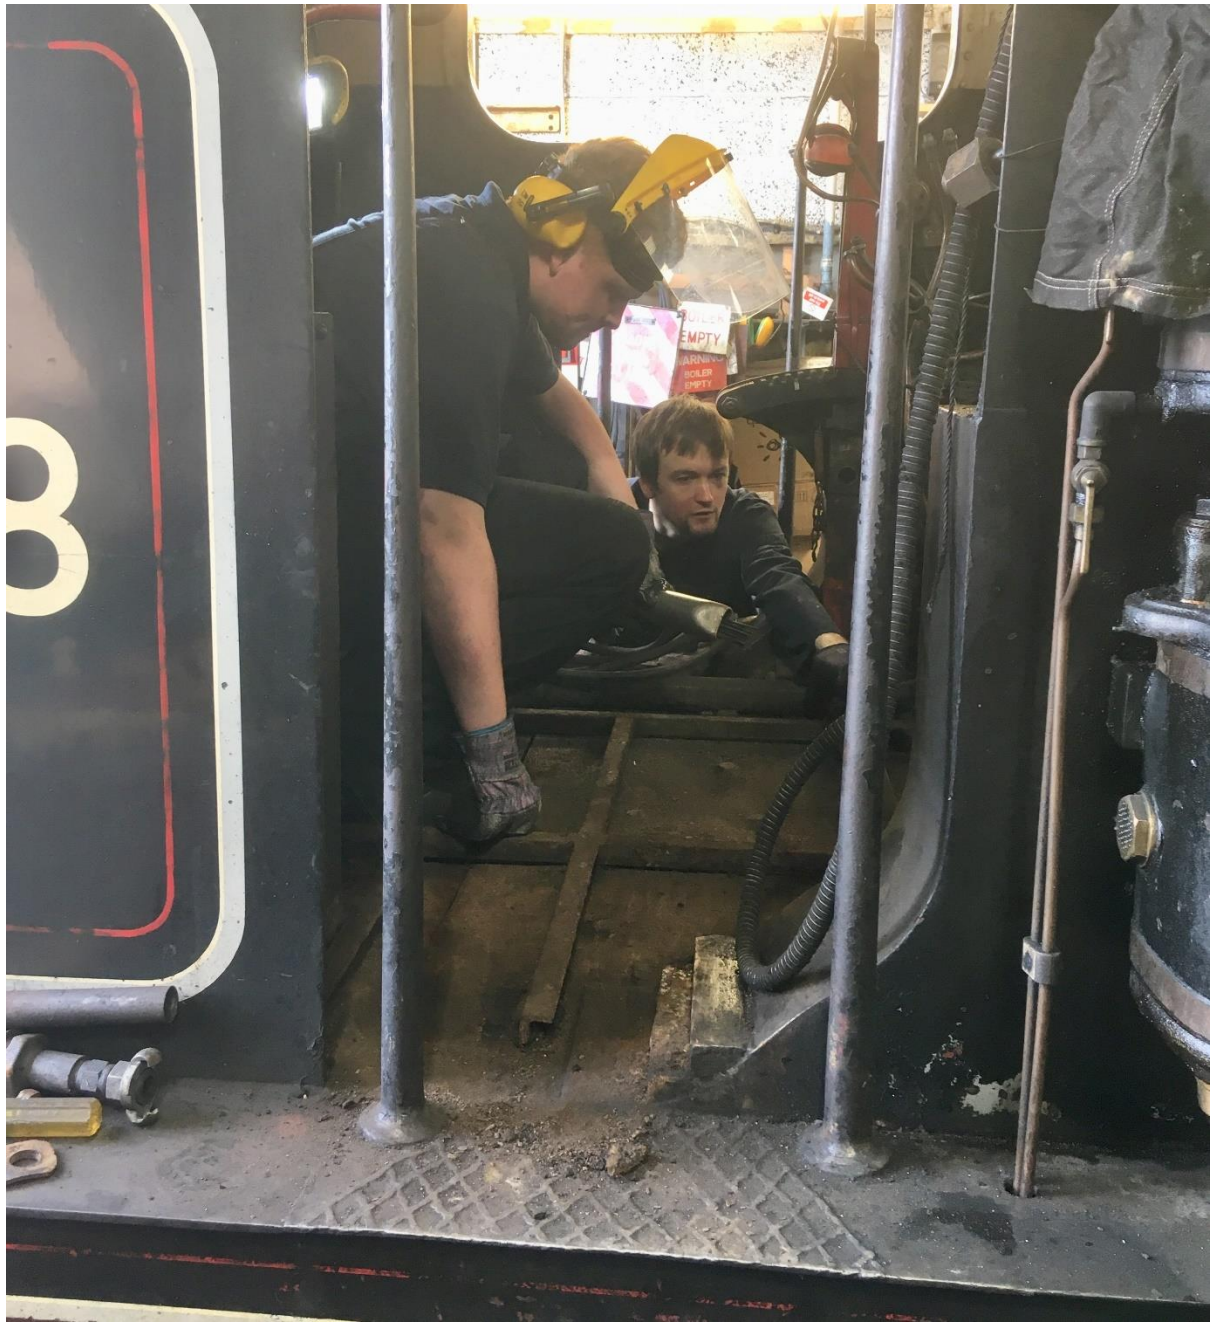
Travis (with needle gun) about to attack the cab floor. James looks on.

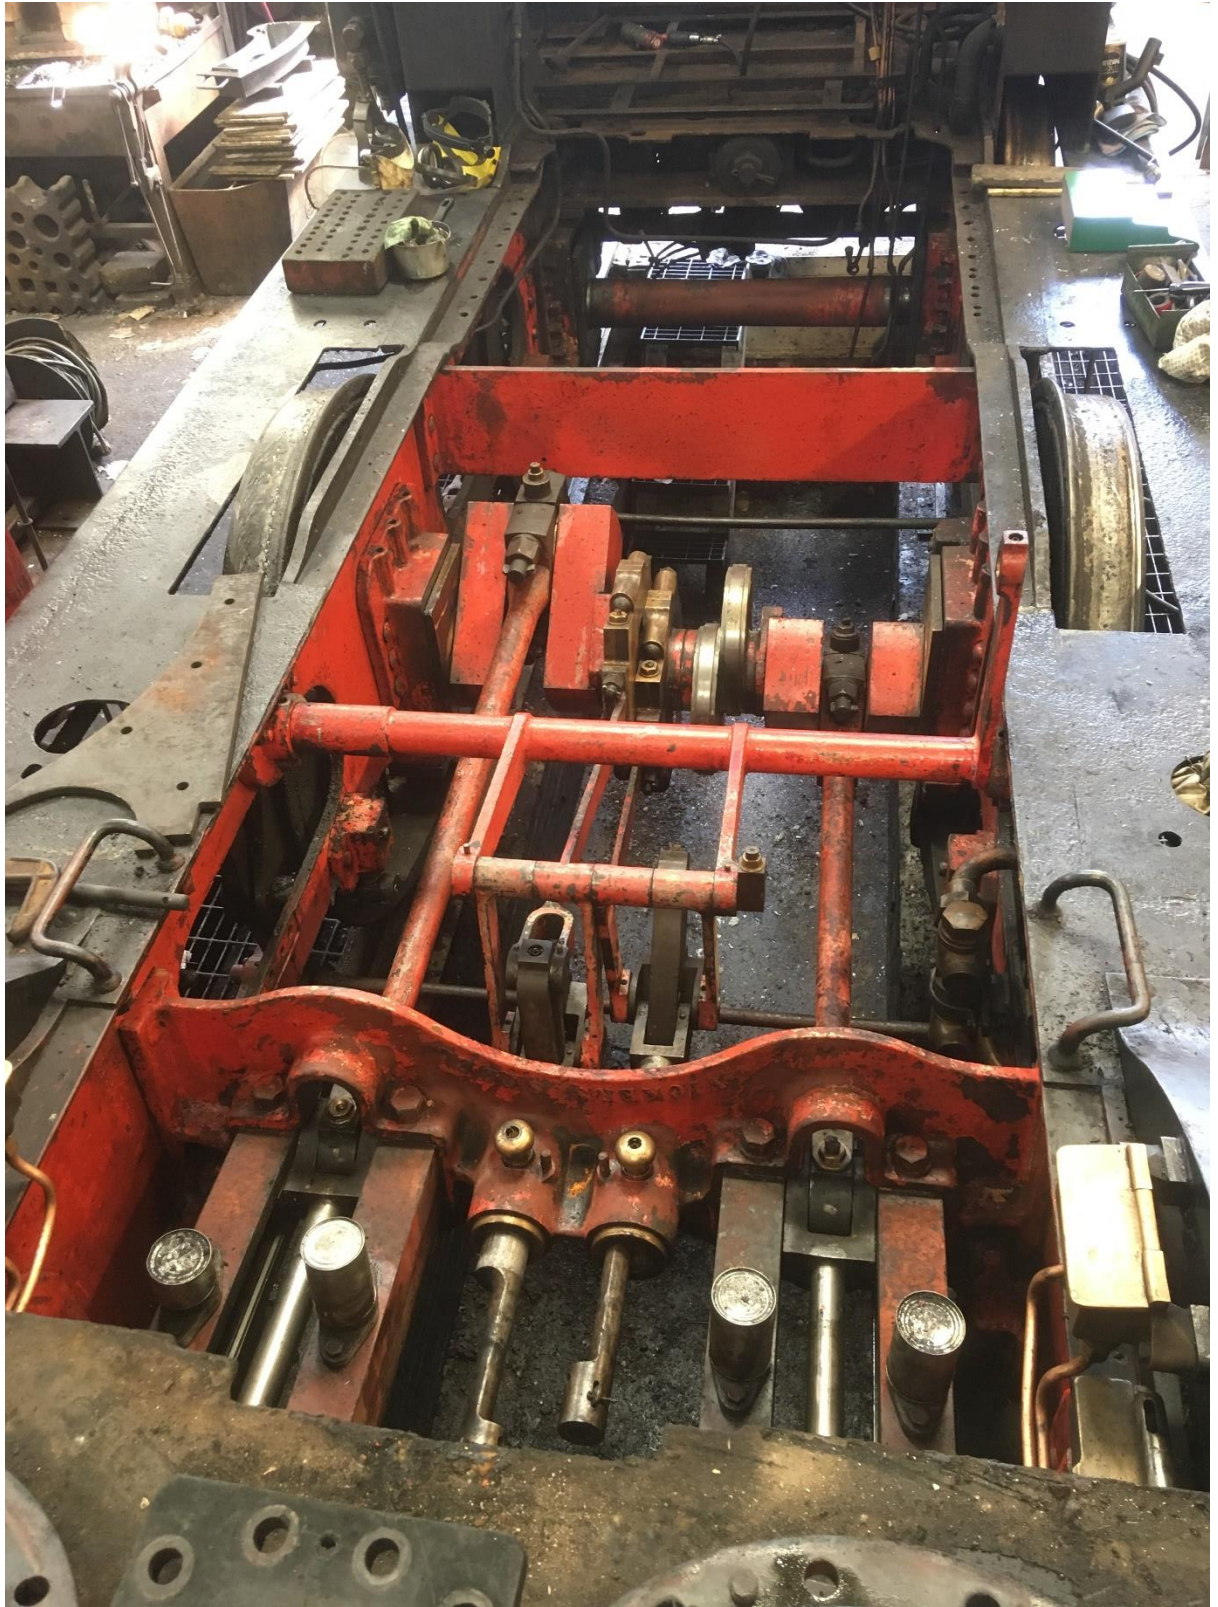
Frames from front to back.

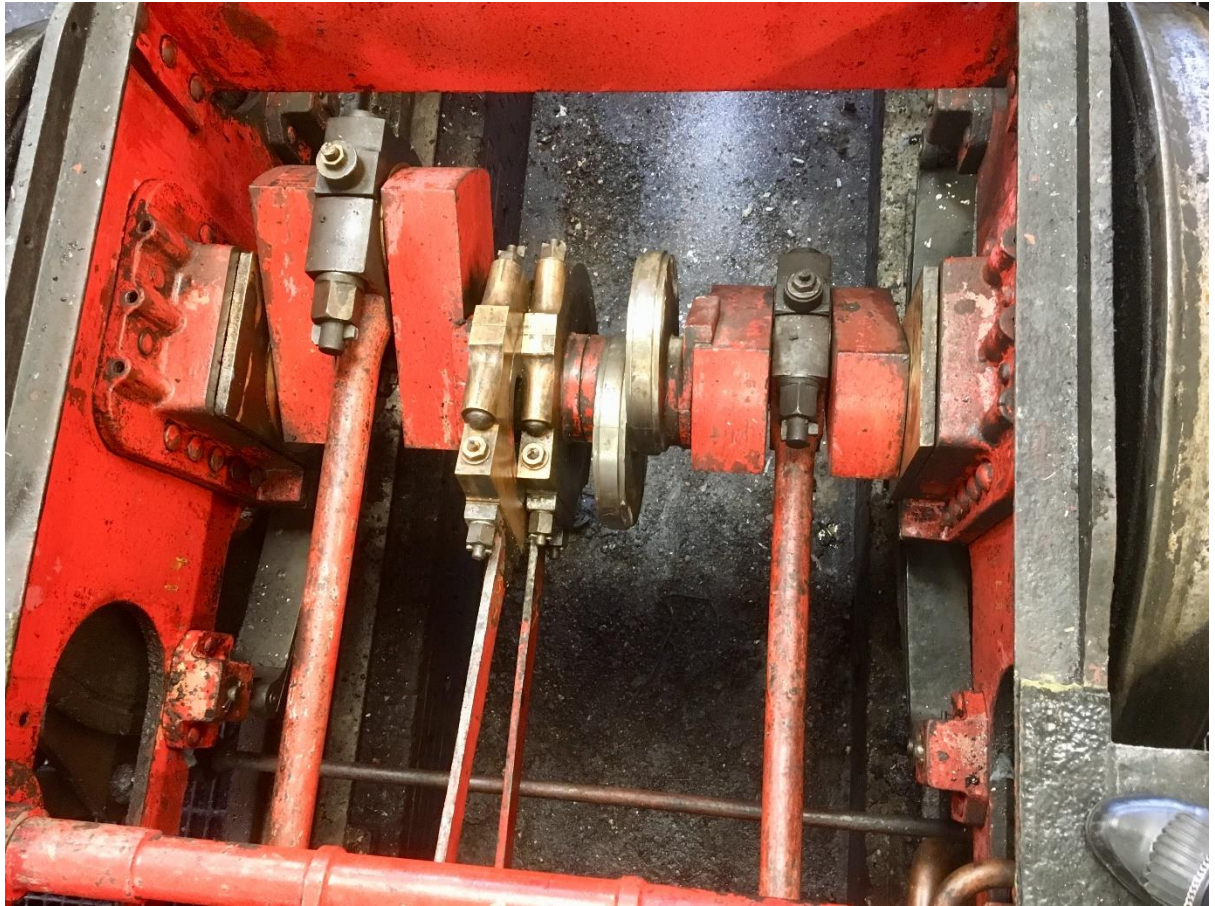
Eccentrics newly white metalled.

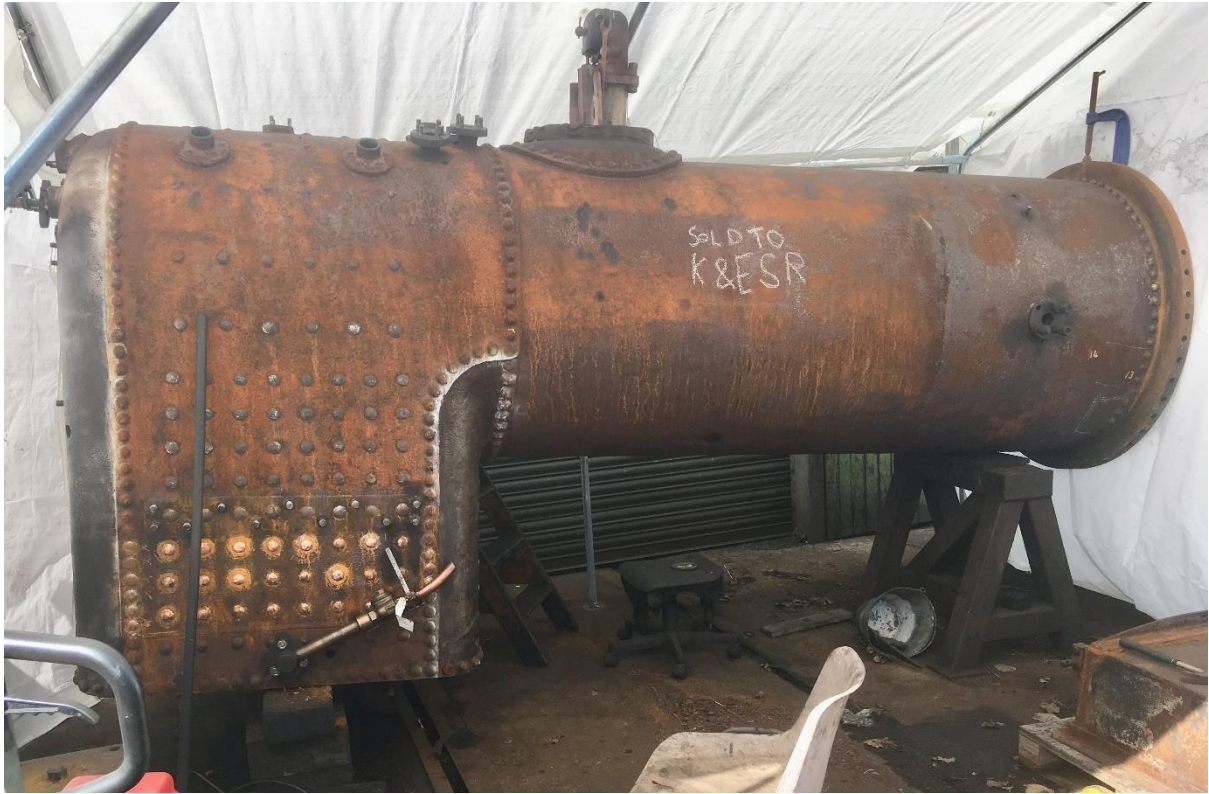
The boiler under its weather cover outside Rolvenden loco shed.

Re-studding the boiler is almost complete: all 70 new studs have been machined by a volunteer at his home for us. Weld repairs have been carried out around the firebox side stays on the outside of the boiler and the throat plate to rebuild where it has corroded.

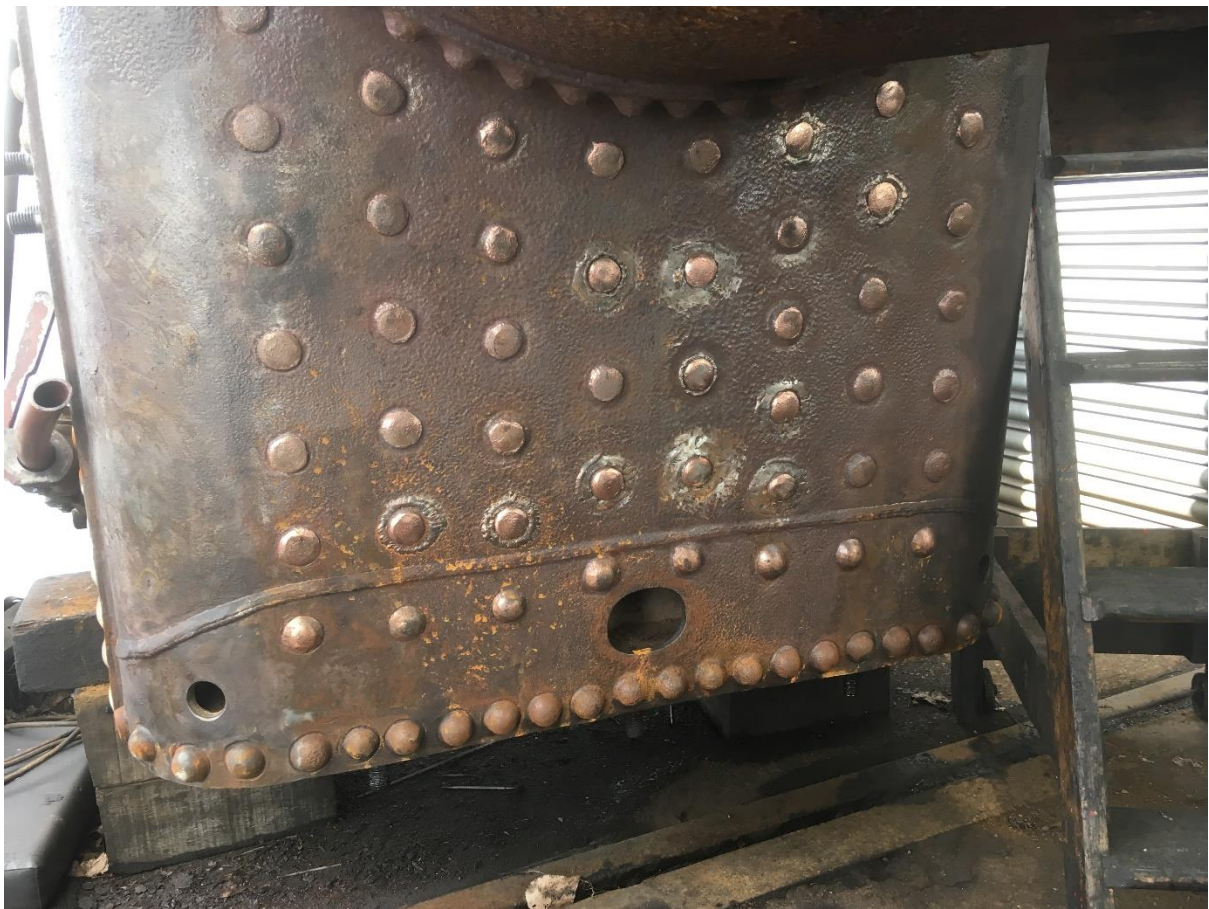
Weld repairs and new studs

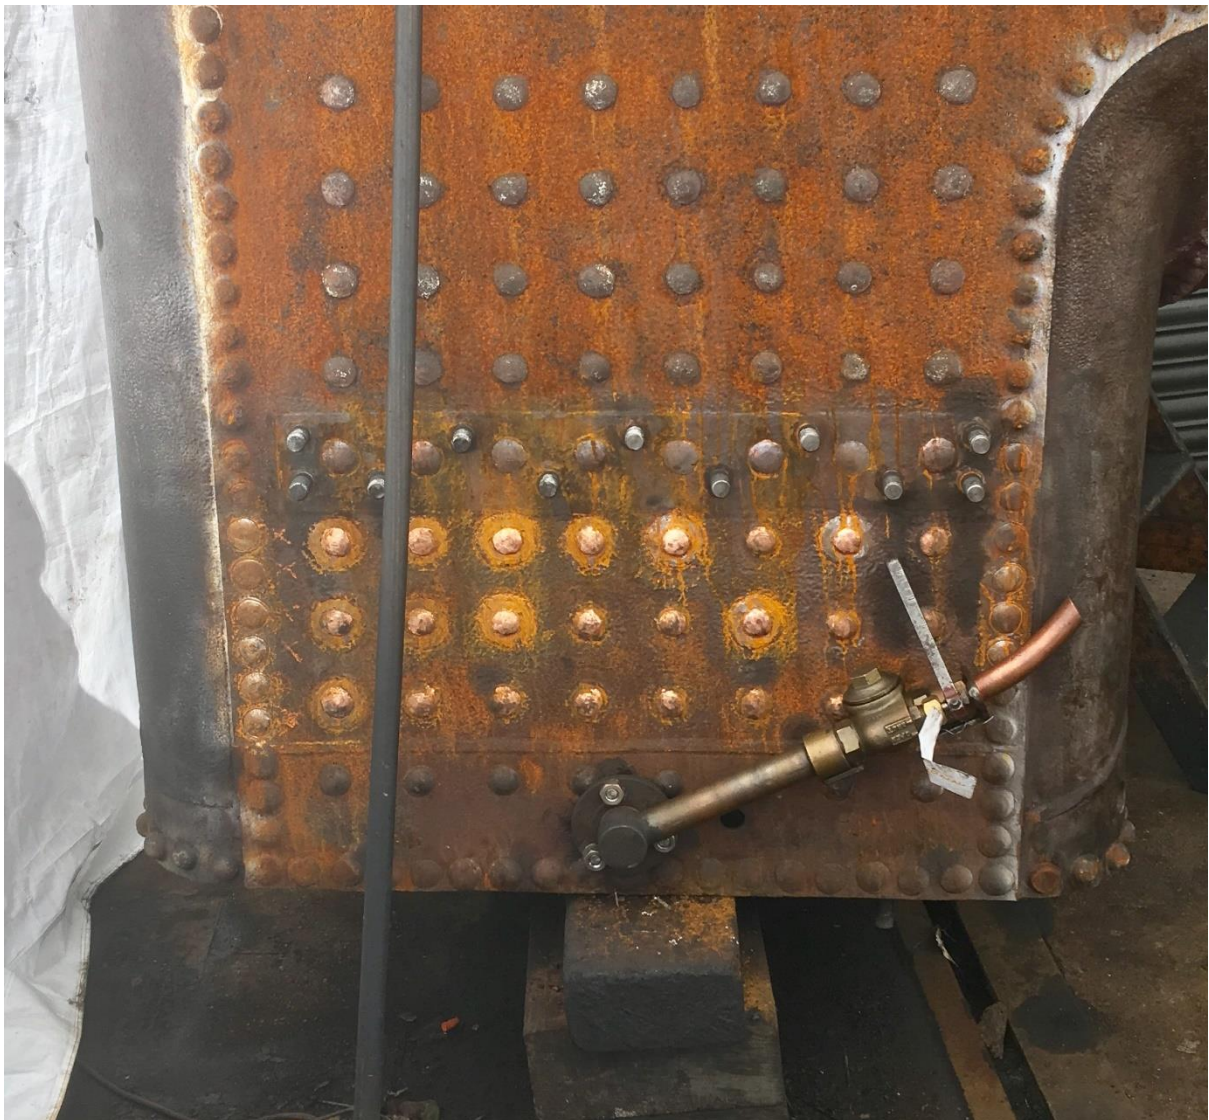
More new studs alongside the blow-down valve.

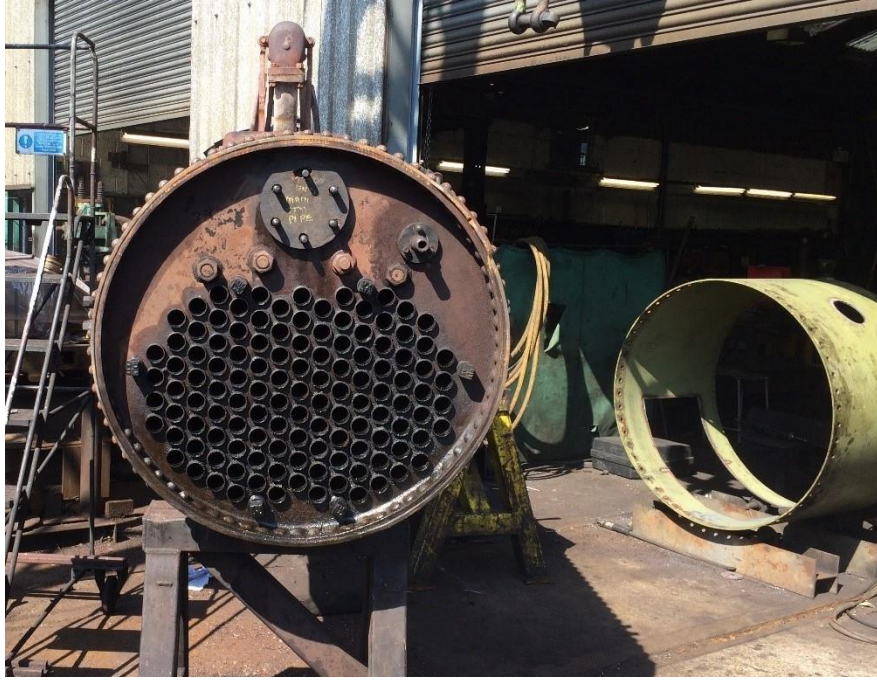
A view of the front tube plate. The tubes have been oiled to protect them from corrosion. The new smoke box is seen to the left.

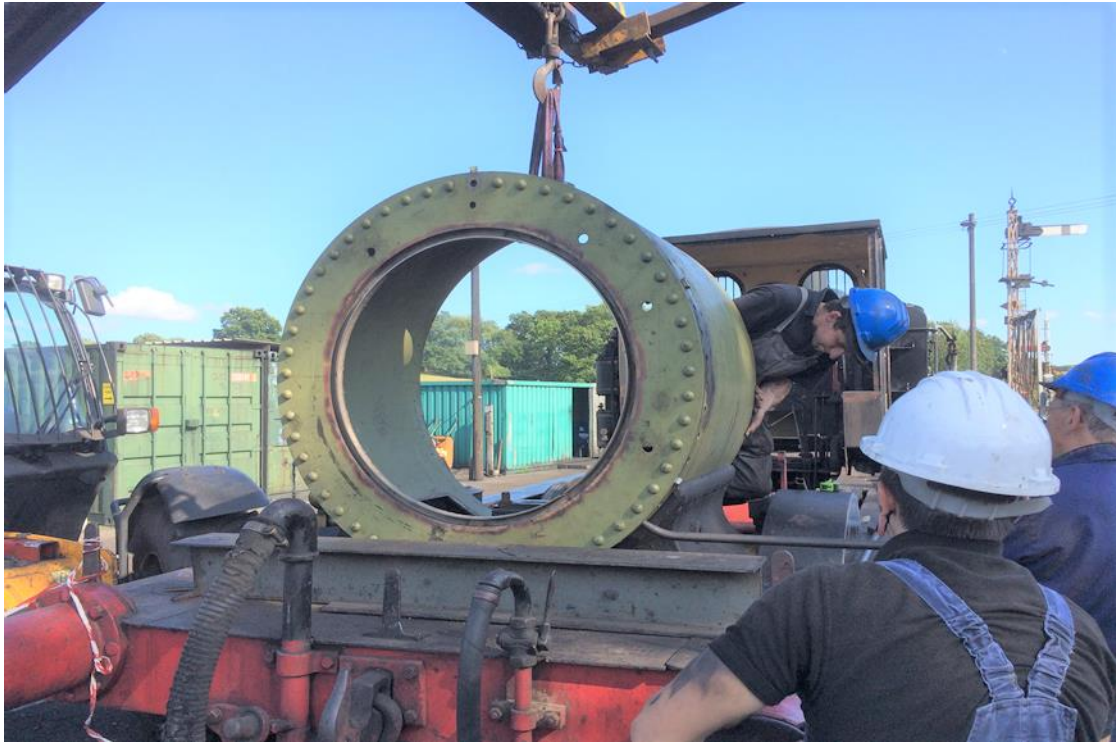
Trial fitting of new rivetted smoke box to saddle.

A new rivetted smokebox has been fabricated by volunteers and a new two inch band welded to the boiler to receive it. Smokebox saddle has had a new plate rolled and fitted where the saddle is broken.
